# California Central Valley Levee Geotechnical Evaluations: Providing Protection For A Growing Population

David T. Simpson, C.E.G.  
URS Corporation

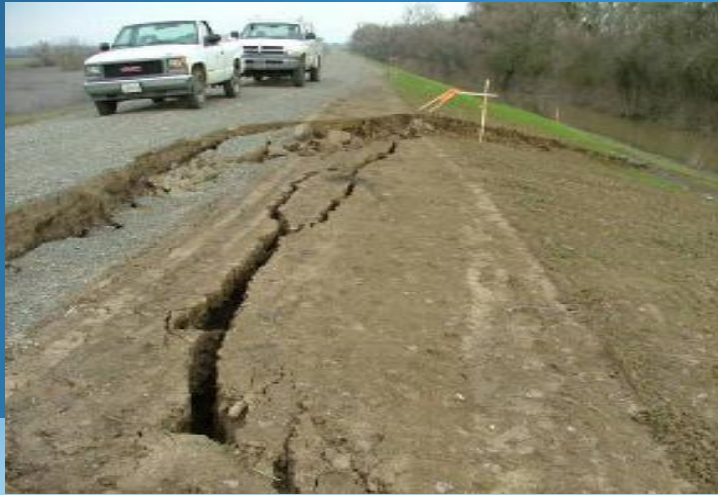
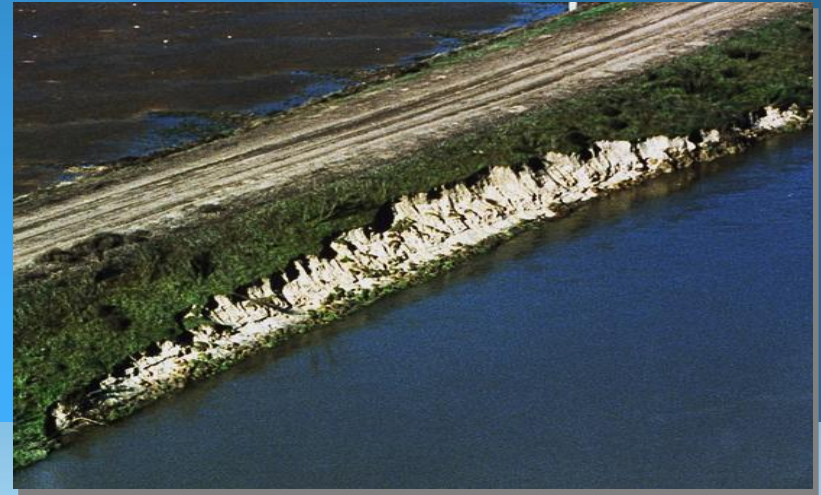
## Erosion and Slope Instability

Bank erosion has reached  
a critical condition

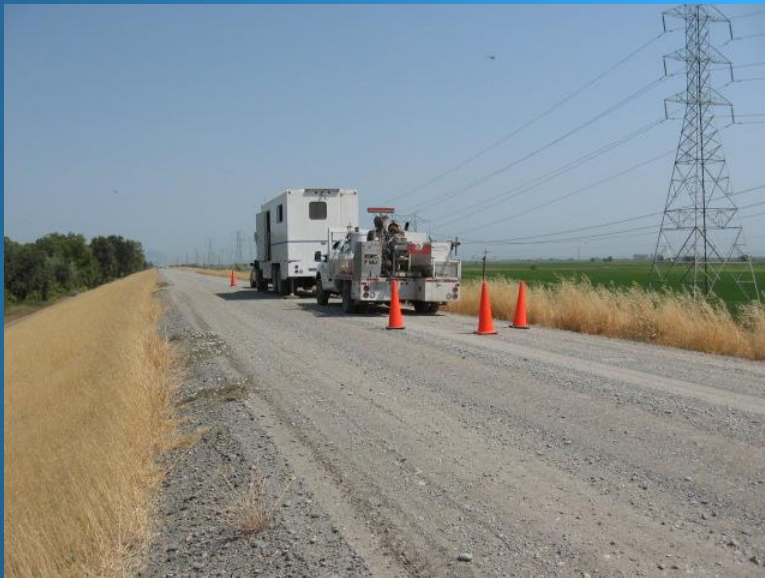
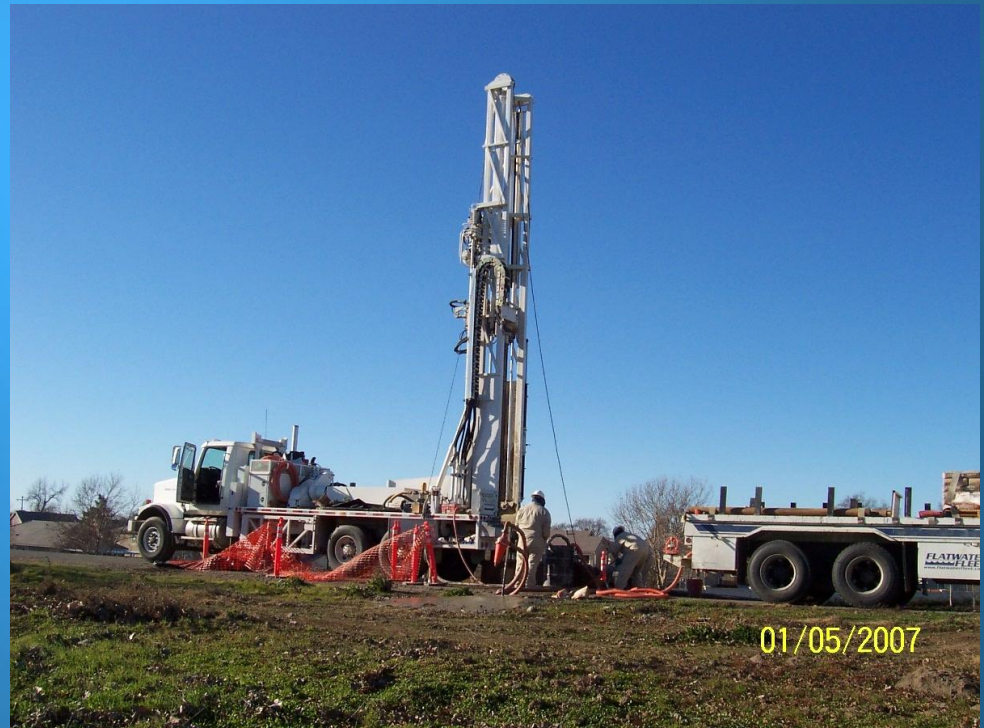
# Subsurface Exploration: Primary Soil Borings

- Drilled on levee crest
- Drilled in known problem areas and on 5000-ft spacing

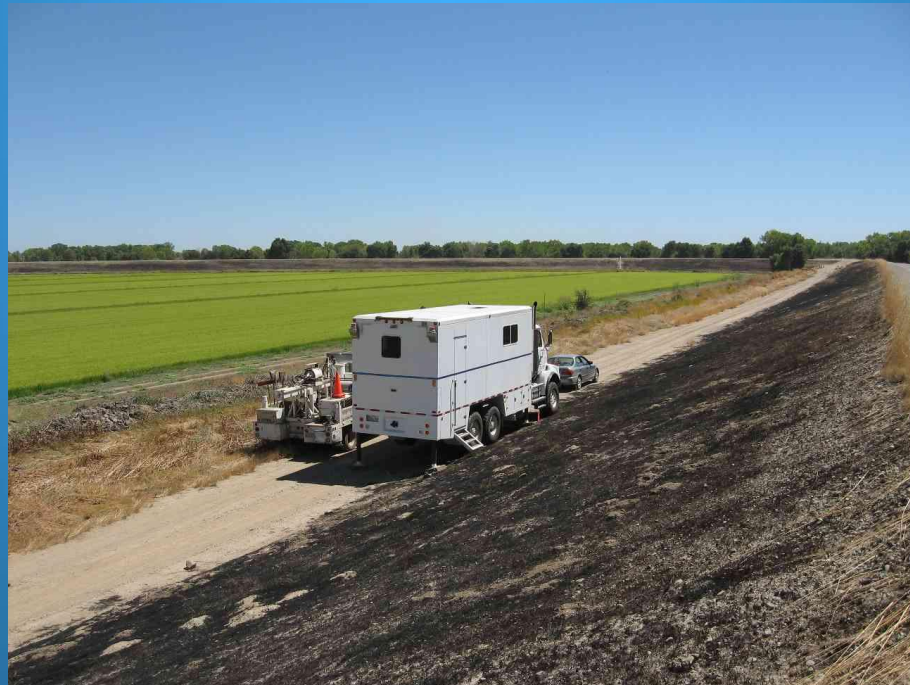
# Subsurface Exploration: Secondary Soil Borings

- Drilled in potential problem areas identified during first phase of exploration
- Drilled on landside toe and offset from toe
