Engineering Laboratory

**NIST Preliminary
Reconnaissance, Building
Performance and Emergency
Communications, Joplin,
Missouri Tornado,
May 22, 2011**

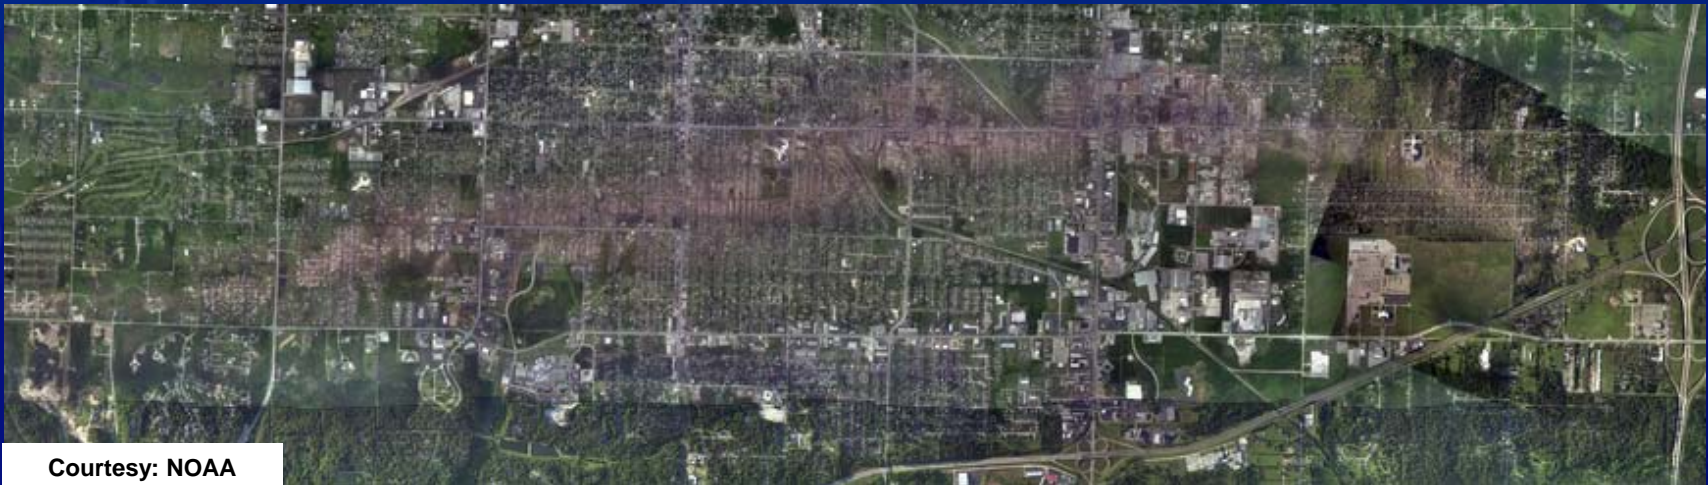
- Touched down in Joplin beginning at 5:41 PM CDT
- Initially rated a “high-end” Enhanced Fujita (EF)-4 tornado with estimated maximum wind speeds from 190-198 mph on May 23rd
- Upgraded to EF-5 on May 24th
 - Estimated maximum wind speeds 200+ mph
 - Maximum path width: $\frac{3}{4}$ mile, length: 13.8 miles (6 miles in Joplin)
 - Source: National Weather Service
- Track: generally West to East across Joplin (Newton and Jasper counties)

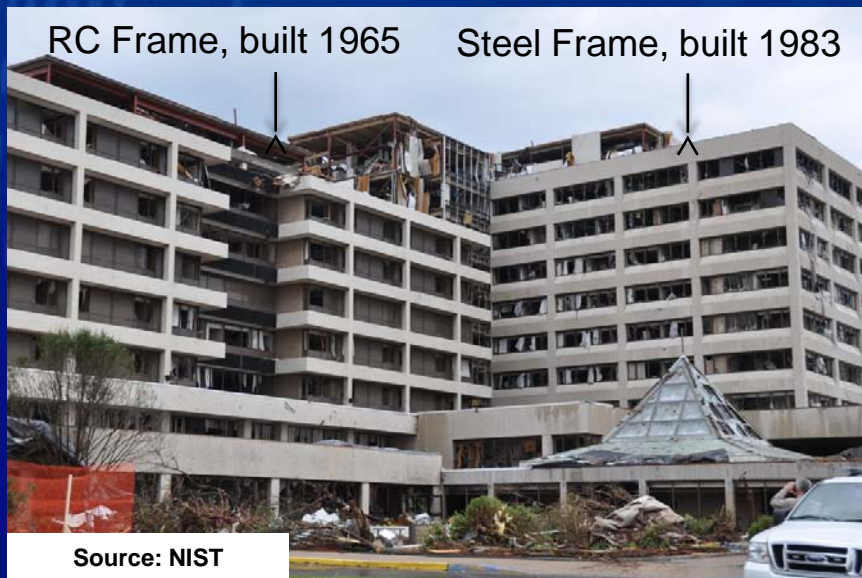
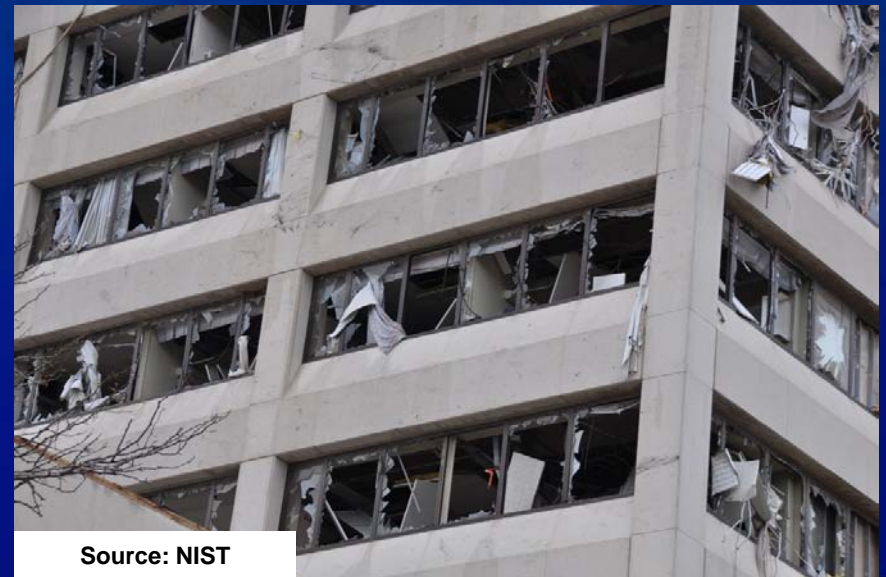
St. John's Medical Center

- RC and Steel Frame Buildings
 - Extensive damage to building envelope and interior
 - Loss of function
 - No observed damage to main wind force resisting systems

- Reinforced concrete frame and steel frame buildings that were surveyed also suffered total loss of function and major damage to the envelope and the interior, but the structural frame remained largely intact

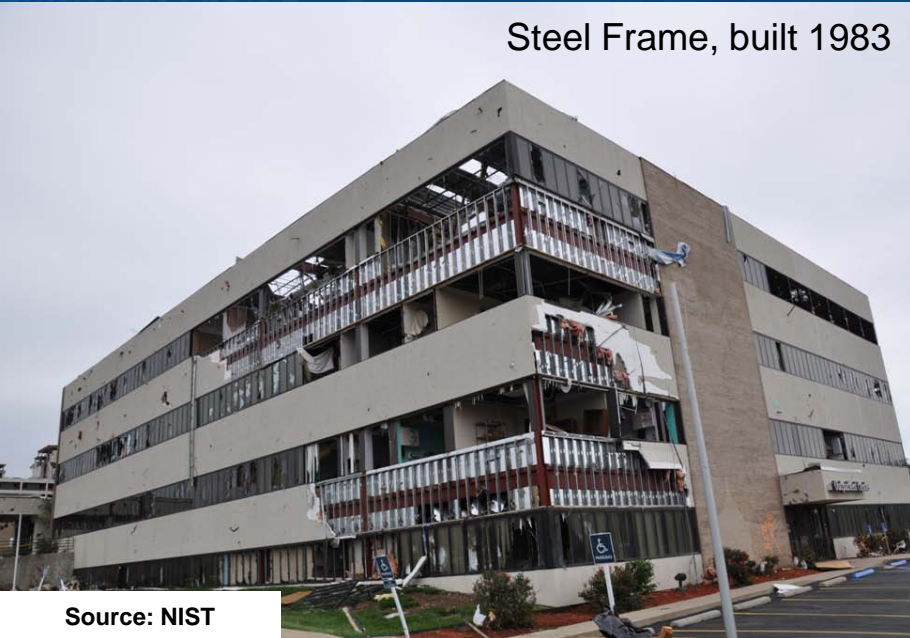
St. John's Medical Center

Steel Frame, built 1983

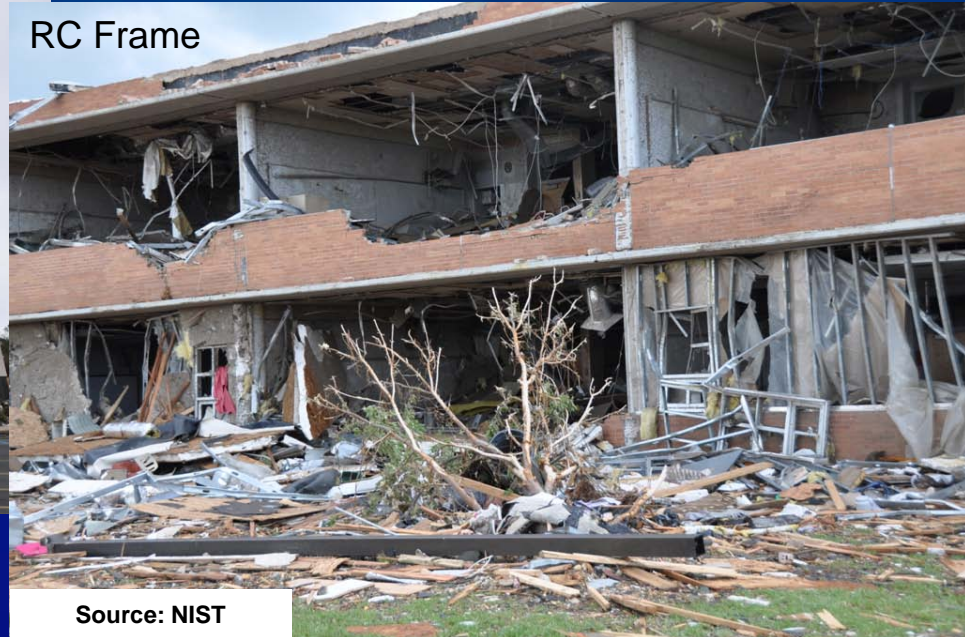
Joplin High School

RC Frame

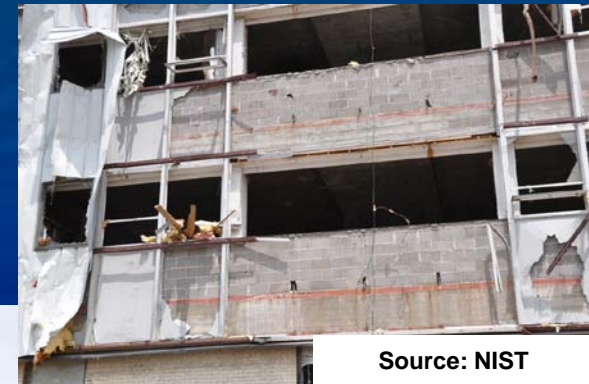
St. Paul's United Methodist Church

Steel Frame

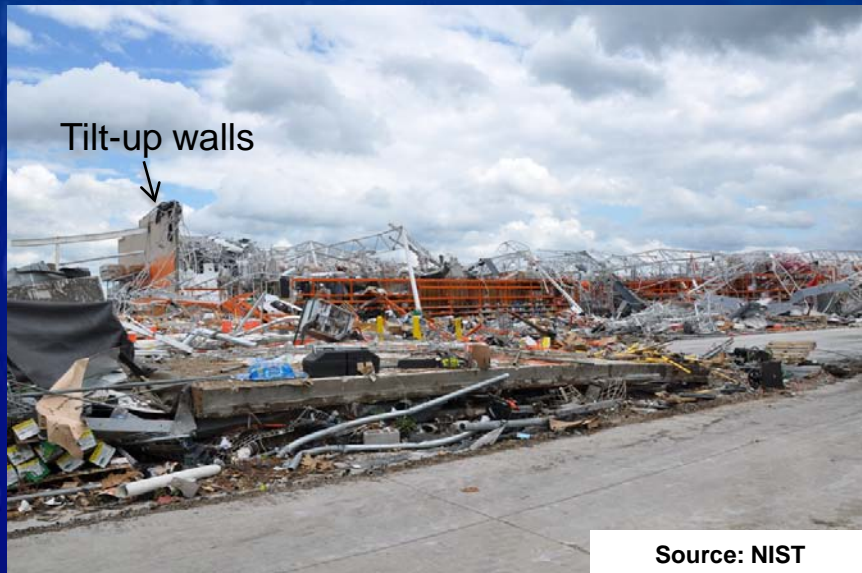
Home Depot

- Precast Concrete Wall Buildings
 - Partial or complete loss of roofing system
 - Failure of roof to wall connections
 - Collapse of wall panels

- Most other buildings, including pre-cast concrete wall construction, metal buildings, concrete and brick masonry, and wood-frame construction, suffered partial or complete collapse

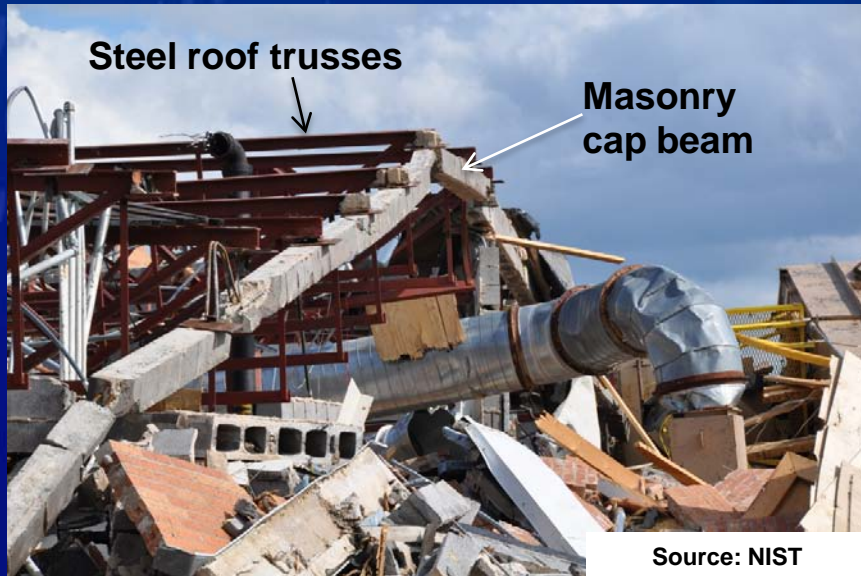
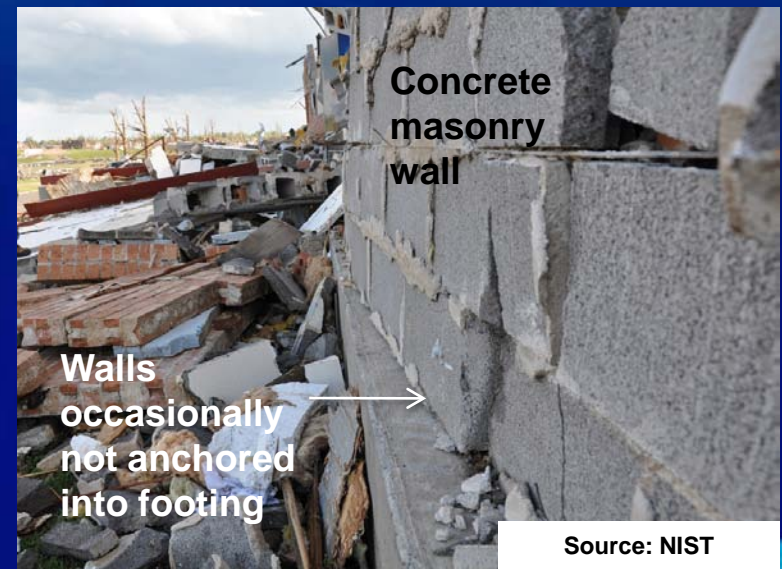
- Concrete Masonry Wall Buildings
 - Partial or complete loss of roofing system
 - Failure of roof to wall connection
 - Collapse of walls

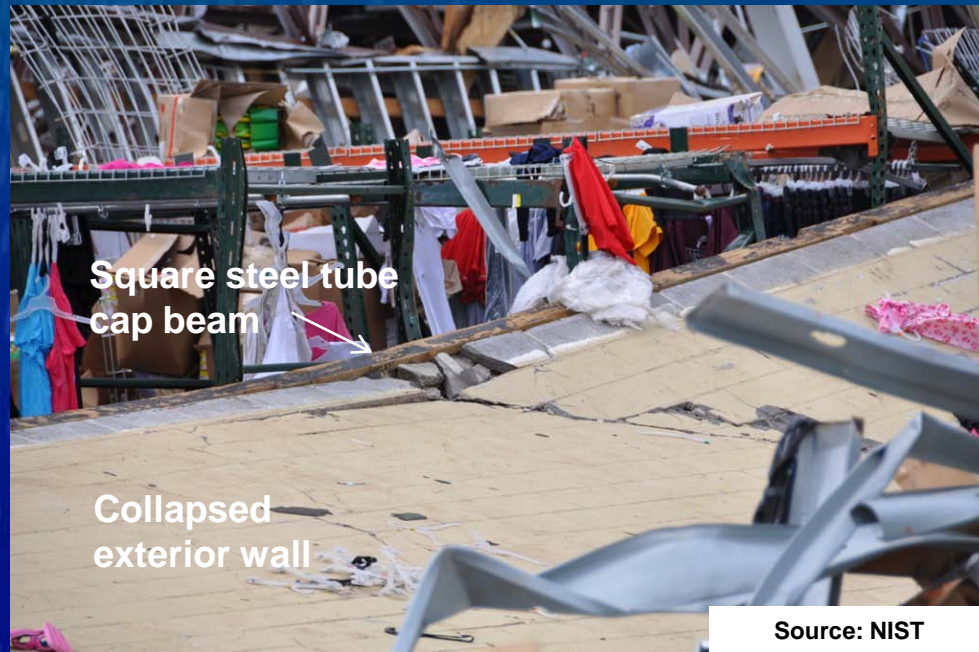
Wal-Mart

- Concrete Masonry Wall Buildings

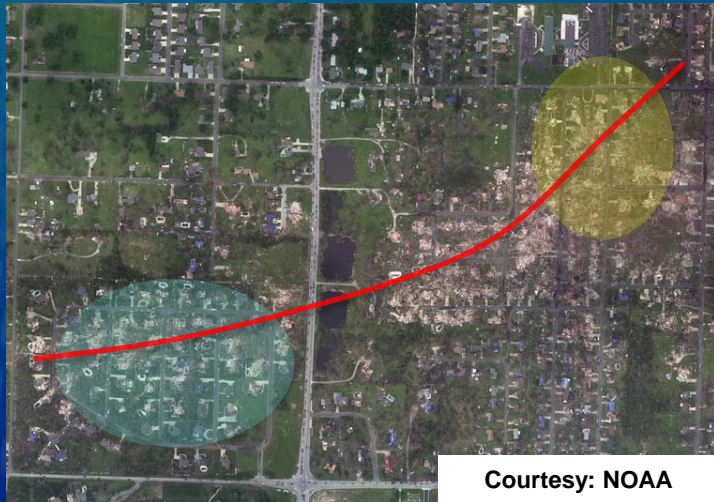
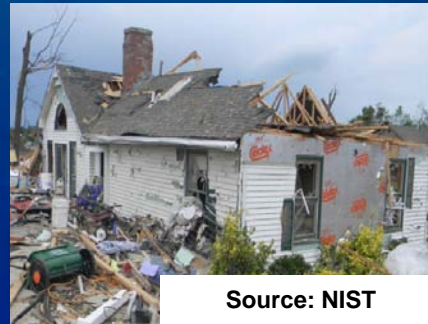
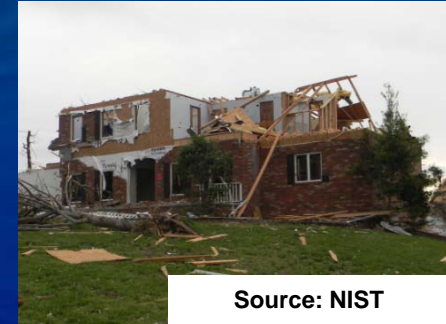
- Surveyed two representative subdivisions near the beginning of the tornado track on the west side of Joplin within damage path
- Different ages of subdivision construction
- Avg. Age: Yellow – Late 1980's, Blue – Early 2000's
- Both types sustained heavy roof damage

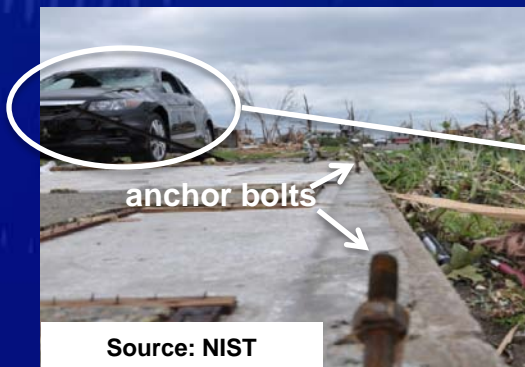
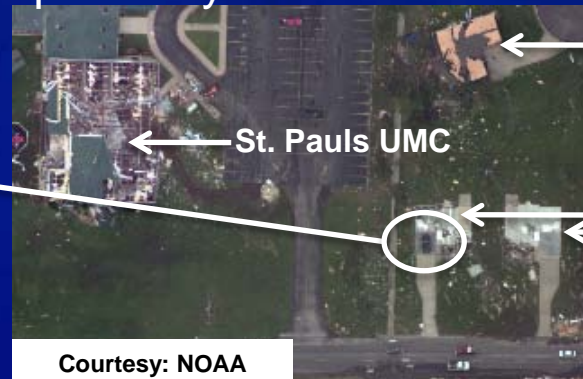
- Houses removed from foundation leaving only anchor bolts in some instances
- In some instances, homes in close proximity suffered a wide range of damage

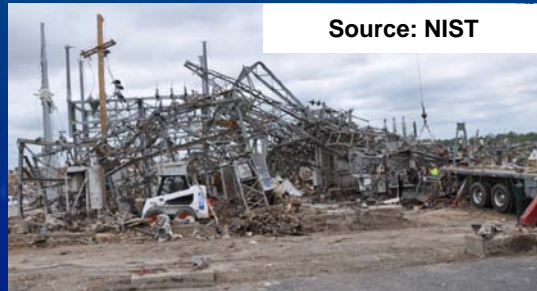
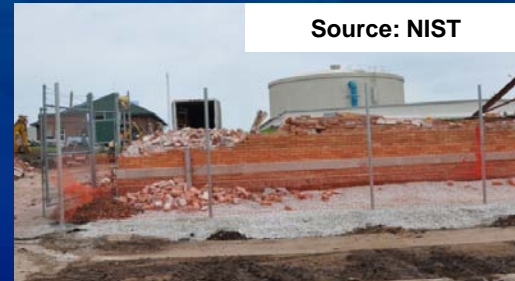
- Power substation damaged, supporting steel frame collapsed
- Unreinforced brick storage building at water treatment plant collapsed. Plant remained operational on back-up power (Source: Missouri American Water Engineering Manager)
